TECHNICAL BULLETIN – TB0039

SUBFLOOR PREPARATION – THE KEY TO SUCCESSFUL INSTALLATIONS

22nd October 2024

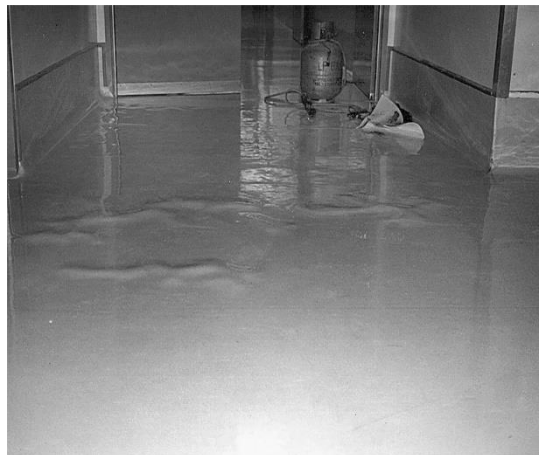
Case Study 1 - Moisture Problems

In this application, commercial vinyl was laid over a floor with rising dampness. The floor was not checked initially for moisture levels, and a moisture barrier was not installed.

The resulting rising moisture penetrated through the ARDEX K15 leveller and was trapped beneath the vinyl, resulting in de-bonding and blistering.

The entire installation had to be removed, a moisture barrier installed, and underlayment and vinyl re-instated

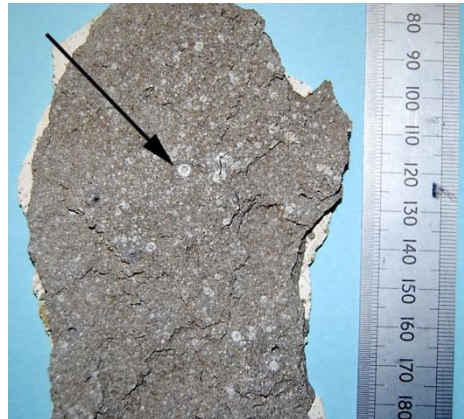
Case Study 2 - Moisture Problems causing the smoothing cement to decompose

Vinyl tiles were laid over a below-grade old concrete floor. ARDEX K55 and ARDEX WPM300 were used. After approximately 18 months, the floors erupted in large, spalled areas.

Investigation of the site indicated a problem with subfloor moisture due to a below-grade slab and leaking roof. The moisture barrier was not applied thick enough to prevent progressive water penetration.

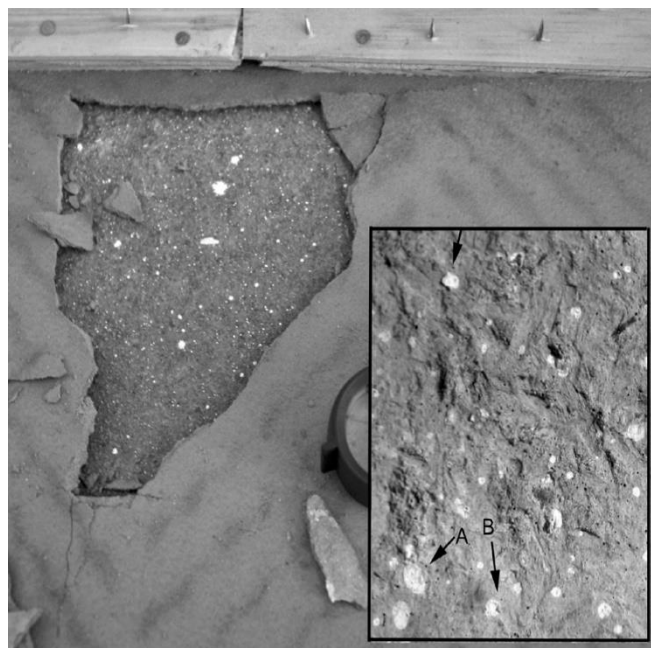
Case Study 3 – Surface contaminants and weak surface layer

A second-storey renovation installed a particle board floor to be covered with carpet. The surface was smoothed with ARDEX Ardite NA. After approximately 6 years, the customer noticed drummy spots under the carpet.

Investigation revealed that the subfloor was contaminated with building residue, including paint or plaster (A-B). The particleboard was also subject to water damage, and the weak surface layer with the water seal was not removed. The ARDEX Ardite NA pulled this weak layer off the floor.

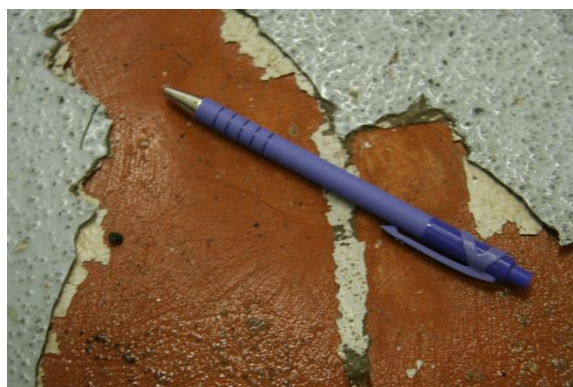
Case Study 4 – Poor surface preparation and thin moisture barrier

Smoothing cement with a coarse finish epoxy coat was applied over a smoothing cement on old terracotta tiles.

Investigation revealed that the moisture barrier was present on only ¼-½ of the required application. The tiles also had a weak surface after grinding.

This led to de-bonding under the

subjected floor loading.
Regardless, ARDEX does not recommend this system.

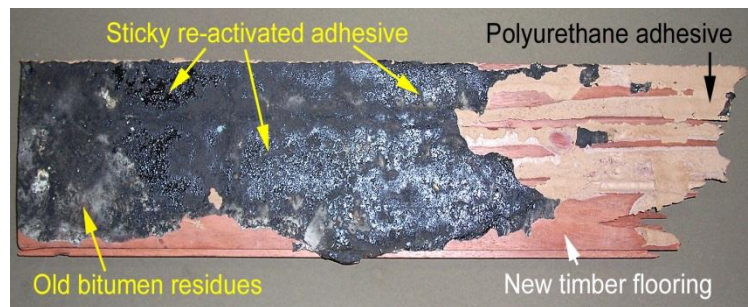
Case Study 5 – Old adhesive not removed

The vinyl was removed from an old concrete floor, but the old 'Blackjack' adhesive was left in place. A 1.5mm ARDEX Ardite NA skim coat was applied, and then strip timber was fixed with polyurethane adhesive. After a short time, the floor de-bonded.

Analysis shows that the polyurethane adhesive contained aggressive solvents, which penetrated through the wafer-thin ARDEX Ardite NA and reactivated the old adhesive, which de-bonded from the floor.

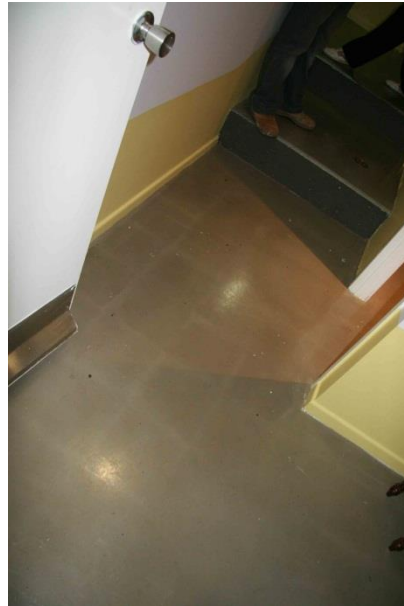
Case Study 5 – ‘Feature floor’ applied over existing tiles

An existing tiled floor in a restaurant was over-coated with ARDEX P82, then ARDEX K12, and a sealer. The grout lines developed show through.

There was no real need to investigate this complaint as it was a non-recommended application. It occurs because of the porosity differences between the grout and tiles. A similar problem can result from ARDEX Feather Finish over tiles before applying vinyl flooring when not enough Feather Finish is applied.

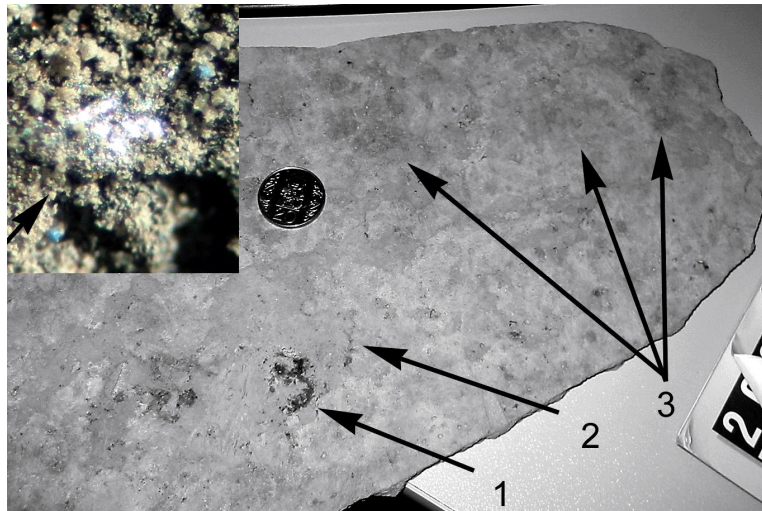
Case Study 6 – Oils and metallic residues on floor

An old aluminium foundry floor was to be used as a sporting complex. It was flood-coated with ARDEX Ardite NA. Sections of the floor subsequently de-bonded.

Examination of the ARDEX Ardite NA revealed the presence of several contaminants, including oil (1), old, weak surface concrete (3), and metal slag (2-inset picture). These indicated the floor had not been mechanically prepared and cleaned

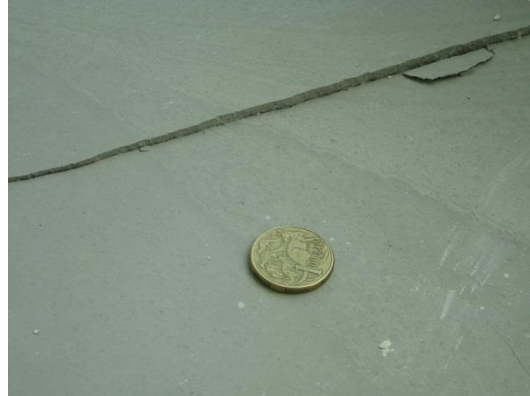
Case Study 7 – High-strength concrete, moving slab, and product too thick

Concrete floors in a multi-level building were smoothed up to 30mm with ARDEX K12, then cracked and debonded.

Examination of the floor showed it to be ground, but the topping only cracked above 12mm thick and around the building perimeter. The complex investigation revealed that the slab was post-tensioned and off-specialized, leading to high strains. Also, the concrete was of unusual mix design. ARDEX E25 polymer-modified ARDEX K12 and normal ARDEX K15 did not crack.

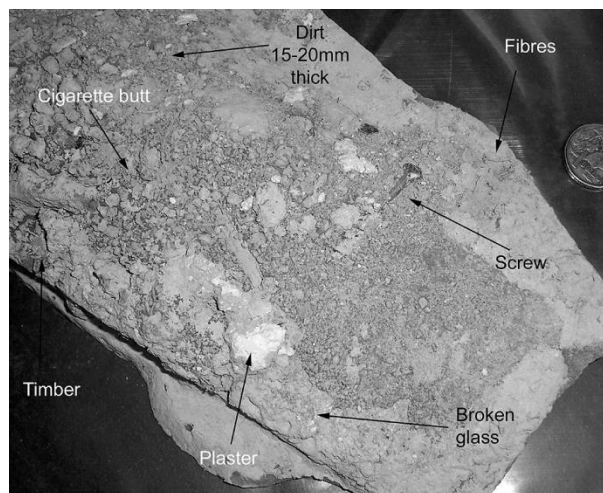
Case Study 8 – Extreme subfloor contamination.

This sample is one of the worst seen by ARDEX to date.

A concrete floor has been 'filled' and 'smoothed' for tiling. Subsequently, the topping cracked and debonded.

The installer had swept the building residues on the floor into the floor's low spots and then poured 15-20mm of smoothing cement over the top!!! No attempt had been made to clean the floor at all.
