## TECHNICAL BULLETIN – TB251

### CONSIDERATIONS AROUND WATERPROOFING AND TILING OVER EXISTING TILED SURFACES - EXTERNALLY

Date, Tuesday, 27 June 2017

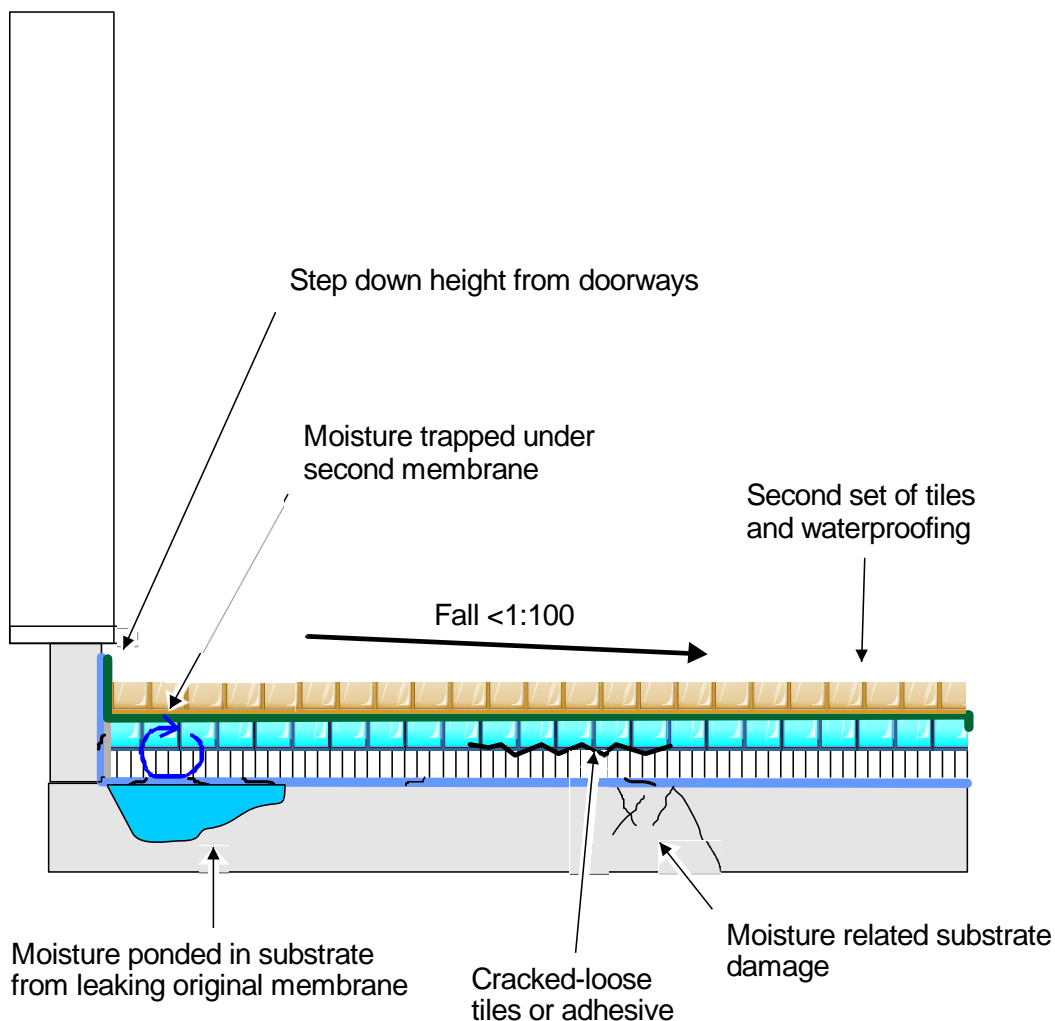
This diagram shows some of the problems that can be expected from this sort of installation.

As a consequence ARDEX is not in favour of this process and recommends a complete reinstallation. As a result we are not offering a standardised system, and it falls back to the persons investigating or doing the rectification to examine all the issues and then see if a viable system can be worked.
