TECHNICAL BULLETIN – TB251

WATERPROOFING AND TILING OVER EXISTING TILED SURFACES - EXTERNALLY

Date: July 30th 2020

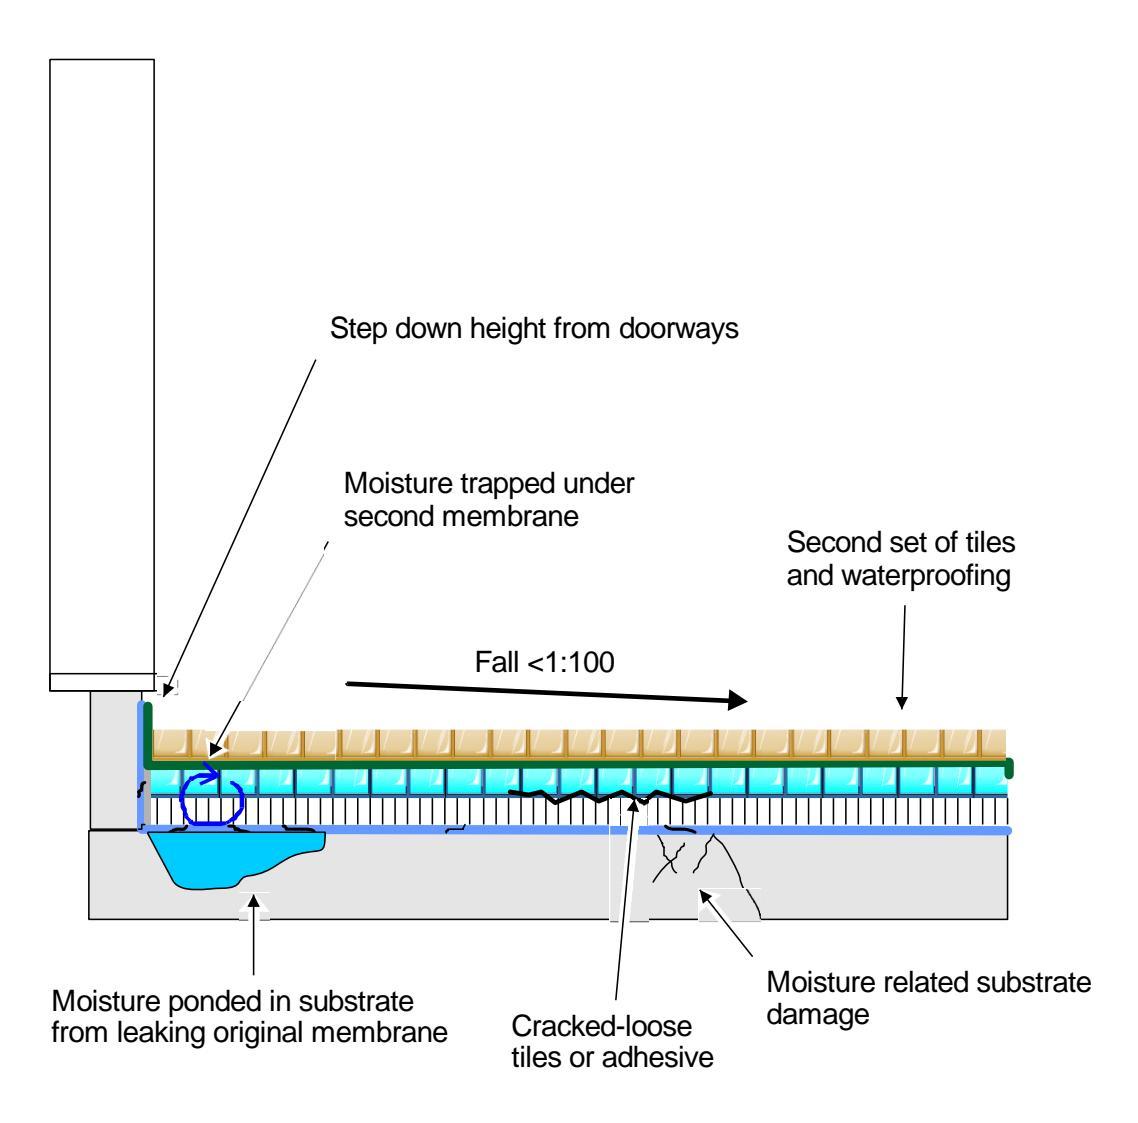
Whilst the lower layer is somewhat isolated from the weather by the upper, the situation still exists for differential movements between the two layers. In particular this can be a problem in hot weather with direct solar exposure, and is worsened by dark coloured tiles heating faster at the surface than tiles lower down. Tiles with different sizes and compositions have different movement properties and hence can display varying expansion and contraction. Whilst the new membrane can act as a stress relief layer, the worst cause would be where the underlying tiles expand more than the overlying and leads to shearing of the membrane and adhesive. Where the overlying tiles move, the main risk is peaking and cracking.

Any existing movement and expansion joints would have to be carried through the second tile layer. This can create difficulties where the tiles are different sizes, and creates an irregular appearance which may not be aesthetically pleasing. Failure to carry joints through risks movement related failures.

This diagram shows some of the problems that can be expected from this sort of installation.

As a consequence ARDEX is not in favour of this process and recommends a complete reinstallation. As a result we are not offering a standardised system, and it falls back to the persons investigating or doing the rectification to examine all the issues and then see if a viable system can be worked.
