## TECHNICAL BULLETIN – TB128

### REINSTATEMENT OF CONCRETE PIERS

23<sup>rd</sup> July 2024

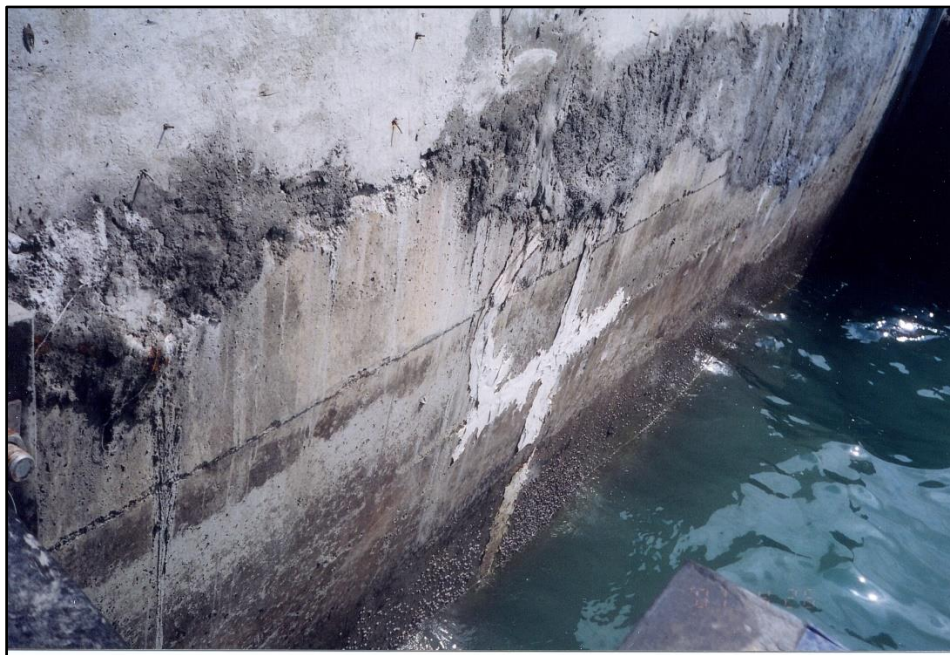
Structural or potentially structural cracks, honeycombed pockets, holes, and faulty or deteriorated construction joints have always existed on this concrete pier and seawall facing the sea. The structure is in a highly variable tidal zone, and the texture of the concrete is generally very rough, allowing maximum impact damage to be caused by the incoming tides.

Years of physical attack from waves and general sea movements and chemical attack from salt water have damaged the integrity of the concrete. The neutralization of the concrete's alkaline passive nature, which protects the reinforcing steel, has resulted in the corrosion of the reinforced steel, causing further physical damage to the concrete.

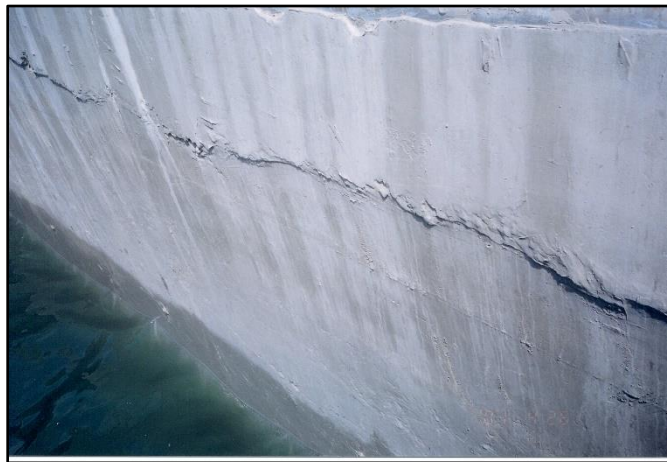
**The ARDEX WPM300 HydrEpoxy has been applied  
to the surface and the incoming tide rises**

The entire surface is then treated by coating with an ARDEX WPM300 HydrEpoxy waterproofing membrane to prevent the ingress of water and chloride ions into the concrete. A primer/bond coat was first applied to achieve maximum bond strength to the substrate concrete. While this coating remained wet, the first coat of ARDEX WPM300 HydrEpoxy was applied progressively with the receding tide in a manner similar to the installation of the concrete repairs. The second coat of ARDEX WPM 300 HydrEpoxy was applied with the receding tide the next day.

The final cosmetic coat consists of ARDEX WPM300 HydrEpoxy mixed with cement in equal volumes and applied using a mohair roller to produce a natural, unobtrusive surface finish.
